Reef slope failure in the northeastern corner of Malè, Maldives

Abstract. This study examines reef-slope failure that occurred on the northeastern corner of Malè Island on the 6th of February, 2002. Malè, the capital of the Maldives, has an area of 1.5 m² and a population of 130,000. The failed slope area was mapped and systematically investigated by comparing aerial photographs and satellite images from 1969 to 2007. The investigation shows that the reef-flat caprock consists of 2 to 3 m of slightly cemented coral and rubble overlying 4 to 6 m of weakly cemented, highly erodible coral sand and rubble located 10 to 30 m down the 30° slope. The failure may have occurred as a single event during which an integral rock mass disintegrated into individual blocks. Radiocarbon dating of the rock samples indicates rapid vertical reef growth, but horizontal progression played a more important role in reef formation. Aerial photographs and satellite images show four additional reef-failure areas on the northern side concentrated in areas of heavy urban-development overburden and continuous vibration from industrial activities. Due to reef failure, the strongly cemented caprock was removed,

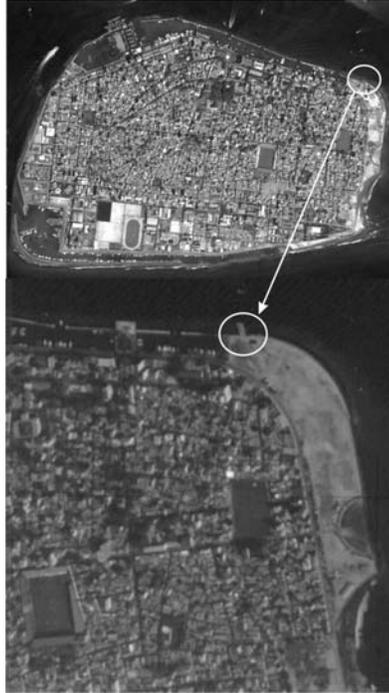
Malè is the capital city of the Maldives with an area of 1.5 m² and a population of 130,000 people. The island, located within and along the south eastern edge of a large north/south-trending atoll, has been reclaimed to the maximum extent possible, and heavy tetra-pod breakwaters have been constructed on the reef flat around the island. Heavy weight from new constructions, buildings, and industrial activity burdens the reclaimed area (Fig. 1).

Figure 1: A Digital Globe® satellite image of Malè taken in 2007, top, aerial photograph of north eastern corner of Malè taken in 1999 at the bottom, showing the solid jetty prior to the collapse.

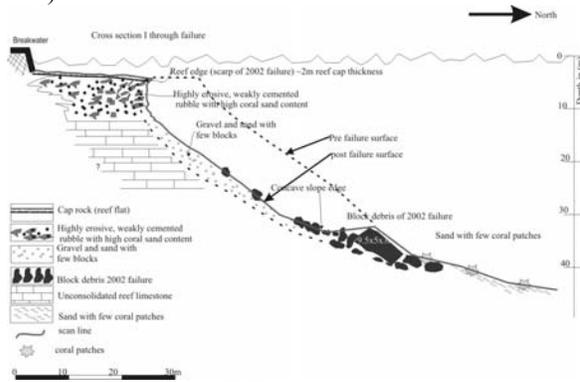
The reef-flat caprock consists of 2- to 3-m-thick slightly cemented coral rock and rubble. Beneath the caprock is a 4- to 6-m-thick weakly cemented highly erodible mixture of coral sand and coral rubble. Farther down (10-30 m), the 30° slope has been built up by loose gravel and sand.

The block field lies on the atoll lagoon floor at a depth of 30 to 40 m. The failure might have occurred as a single event, and as the rock mass was in motion, the mass disintegrated into individual blocks to form the block field. Total volume of the rockslide is estimated to be several thousand cubic meters (Figs. 2 & 3).

Figure 2: Cross section of failure area.

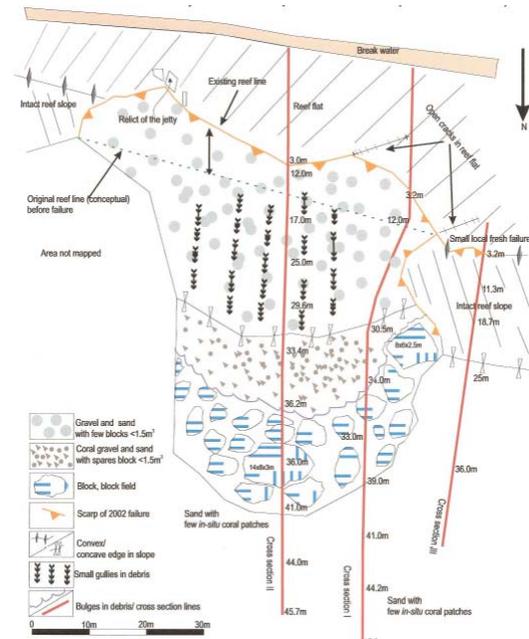
Figure 3: Plan view of failure area.

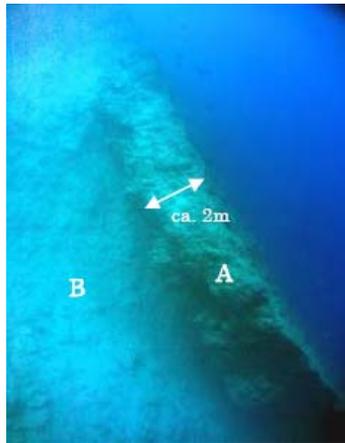
The collapsed scarp shows that the reef surface is consolidated at the top 2 to 3 m by the accretion of tabular, massive, and stubby branching corals. The sedimentary structure changes gradually to the coral casts near the bottom of the scarp (Fig. 4).

The study found that the geomechanical cause of the slide is a combined weakly cemented layer of coral sand and rubble several meters thick and urban construction. Similar subsurface conditions were determined by core drilling at Rasdhoo atoll (Gischler et al. 2008).

It is evident that the reef scarp, including the weak layer, is exposed to prevailing current and wave action and hence to active scouring beneath the consolidated layer. It is expected that parts of the reef will continue to fall into the atoll lagoon, leading to additional backward retreat of the reef edge toward the breakwater.

Figure 4: Scarp of the collapsed area showing the composition of the Malè house reef: A is the consolidated hard layer and B is the unconsolidated reef framework.

Further investigation is required to determine the lateral extent of the weak layer. Such an investigation is crucial prior to taking any remedial measure to stabilize the unstable reef slope. Further analysis of slope stability is also needed (Damjanac 1999).

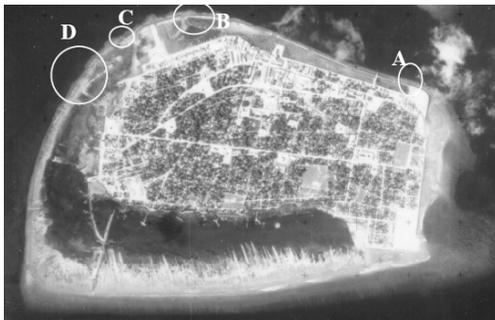
The reef surrounding Malè Island is continuous, and no collapsed area is found in aerial photographs taken in 1969 (Fig. 5). The reef area of the northeastern corner had not failed, whereas the area on the northwestern part had failed. Furthermore, satellite images taken in 2007 showed failure at four circled areas (Fig. 6). Those failures are concentrated in the areas of heavy construction and continuous industrial vibration. Although these areas are clearly visible in the photos, they need to be validated through field observations.

Figure 5: Aerial photograph taken in 1969.

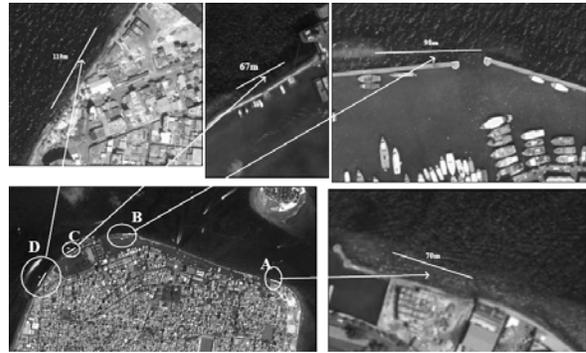
Figure 6: Magnified view of satellite image (2007) showing the failed areas on the northern reef of Malè.
