# Real-time coral stress observations before, during, and after beach nourishment dredging offshore SE Florida

**Abstract.** Beach nourishment in Southeast Florida involves dredging sand source borrow areas located between offshore reefs. From May 2005 to February 2006 Broward County, FL. nourished 10.9 km of beach with  $1.5 \times 10^6$  m<sup>3</sup> of sand. As part of a program to monitor potential reef community impacts, a visual stress index was developed from laboratory experiments and histological analyses for three stony coral species (*Montastraea cavernosa*, *Solenastrea bournoni*, and *Siderastrea siderea*). Scoring involved healthy = 0; moderately stressed = 1 (polyp swelling, increased mucus); markedly stressed = 2 (coloration changes, increased mucus secretion, tissue thinning); and severely stressed = 3 (severe swelling/thinning tissue erosion/necrosis). Colonies were scored weekly at sites adjacent to borrow areas and control sites pre-, during, and post-dredging. Permit conditions were established which would suspend dredging based on mean stress index values above 1.5 at 50% of monitored sites adjacent to borrow areas. This condition was never met. However, thr

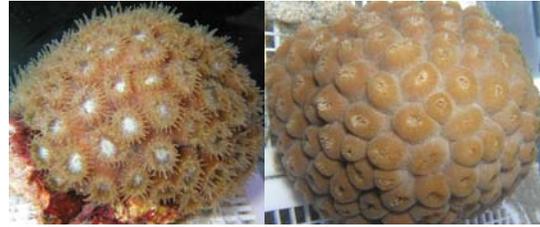
Figure 2a: STRESS LEVEL 0: Color appears normal; polyps are fully extended or loosely retracted; no tissue swelling; no apparent mucus sheets over colony.

The stress index was developed in the laboratory and verified histopathologically (Vargas-Angel, et al., 2006). Average values above 1.5 (n=6) at 50% of sites surrounding a particular borrow area would trigger cessation of dredging at that borrow until average stress fell below threshold. Figure 2 shows typical observable stress responses of *Montastraea cavernosa* for each stress index level. Treatment study sites were established adjacent to each borrow area (Figure 1) and control sites established 4-5 km north (3 sites) and south (5 sites) of the dredge operating area. Six colonies among the three species were selected at each site. Sites were visited and stress observations made weekly for thirteen weeks pre-construction, weekly during construction (38 continuous weeks with two exceptions due to tropical cyclone activity, and weekly for eight weeks post-construction. Additional observations from non-project colonies were made occasionally from outside the study sites to verify that visual observations were close or identical to histological stress determined in the lab.

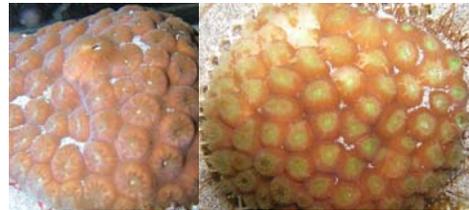
Figure 2c: STRESS LEVEL 2: Normal coloration to patchy bleaching. Normal texture lines begin to disappear; polyps appear "melted"; severe tissue swelling and apparent tissue thinning; presence of mucus sheets and sand accumulations between polyps.

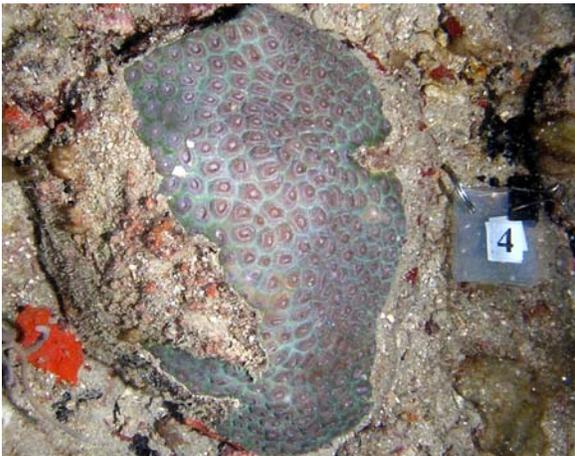
Figure 3a. Example of a monitored *M. cavernosa* colony at stress level 0 during construction on July 5, 2005.

Figure 3 presents photographic evidence that the observed level of stress for a *Montastraea cavernosa* colony from one of the treatment sites changed from level 0 to level 2 during construction and returned to level 1 after construction was completed. Average stress values (Figure 4) at treatment sites (n = 26 sites and 156 colonies) and control sites (n = 8 sites and 48

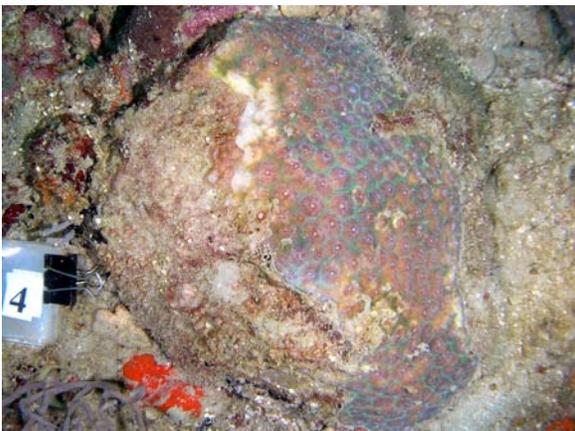
Figure 3b. The same colony at stress level 2 during construction on December 5, 2005, after the passage of three tropical cyclones.

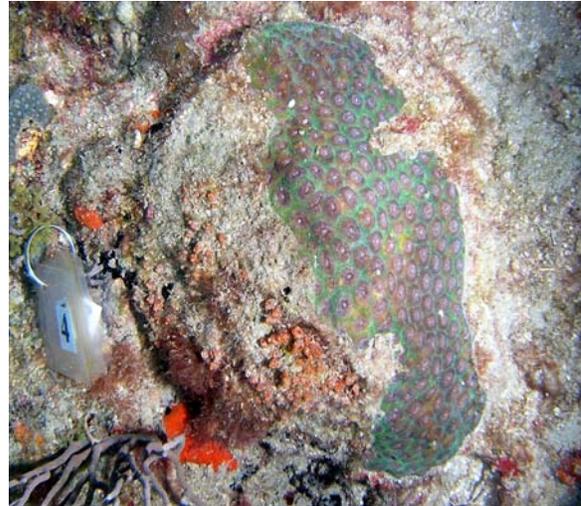
Figure 3c. The same colony showing some tissue loss in the upper left, however, the remaining colony has recovered to stress level 1 during post construction on March 22, 2006
